A Citizen-Based Approach to Stormwater Management:

Raingardens to Improve Impaired Waters

Final Report

Powderhorn Lake Minneapolis, Minnesota

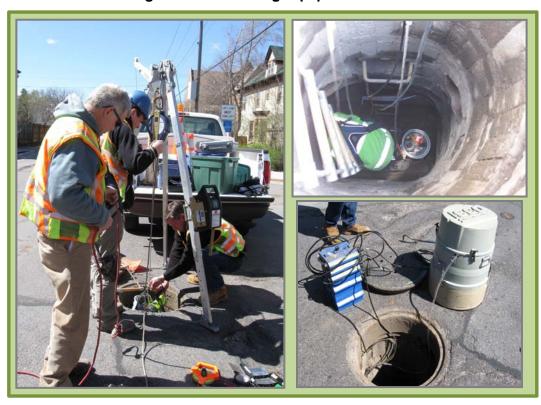
Figure 9 - Monitoring Equipment & Sites

Monitoring equipment was installed in the storm sewers at two locations to record stormwater flow for the test and control watersheds beginning in Spring 2009 through November 2011. The MPRB installed equipment & collected data for the three year period as shown in Figure 9 for one of the sites. Approximately 10 water quality samples were taken each year and analyzed for total phosphorus and total suspended solids. Equipment was removed in the winter months.

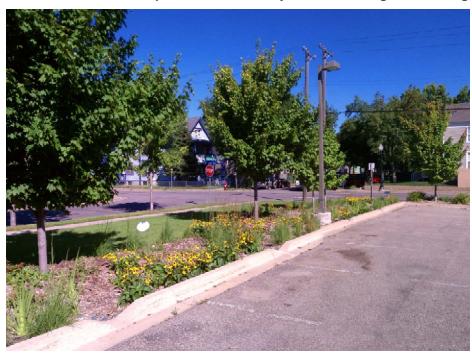
Figure 23 - All God's Children, Metropolitan Community Church Raingarden - August 2011

Heavy equipment was used in a few instances. Five raingardens were built at churches to capture surface runoff from their parking lots (Figure 23). Three of these five were built with the help of an excavator. Much of the soil around a parking lot is heavily compacted and is

very difficult to dig by hand. Also, the scale of these gardens was much larger to accommodate the scale of the much larger drainage area.

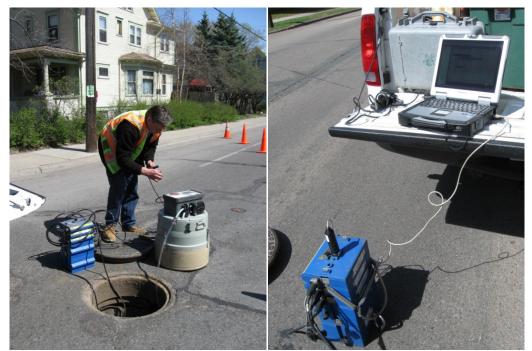
Figure 3. Flow and Water Quality Monitoring Equipment

Columbus Avenue South. The monitoring equipment was installed in 24" RCP at these new locations. An example of the flow and water quality monitoring equipment is shown below in Figure 3.

When uninstalling the monitoring equipment for the 2009 season, it was noted that both of the new sites had significant sediment accumulation around the invert AV probes. Offset AV probes were installed in 2010 and 2011 to avoid sedimentation and interference with accurate flow measurement.
